**GEOTECHNICAL/GEOLOGICAL
RECONNAISSANCE STUDY REPORT**

CHIGNIK LAGOON ROAD

CHIGNIK LAGOON, ALASKA

January 27, 2012
W.O. 60936
Report No. 5288
Area 3

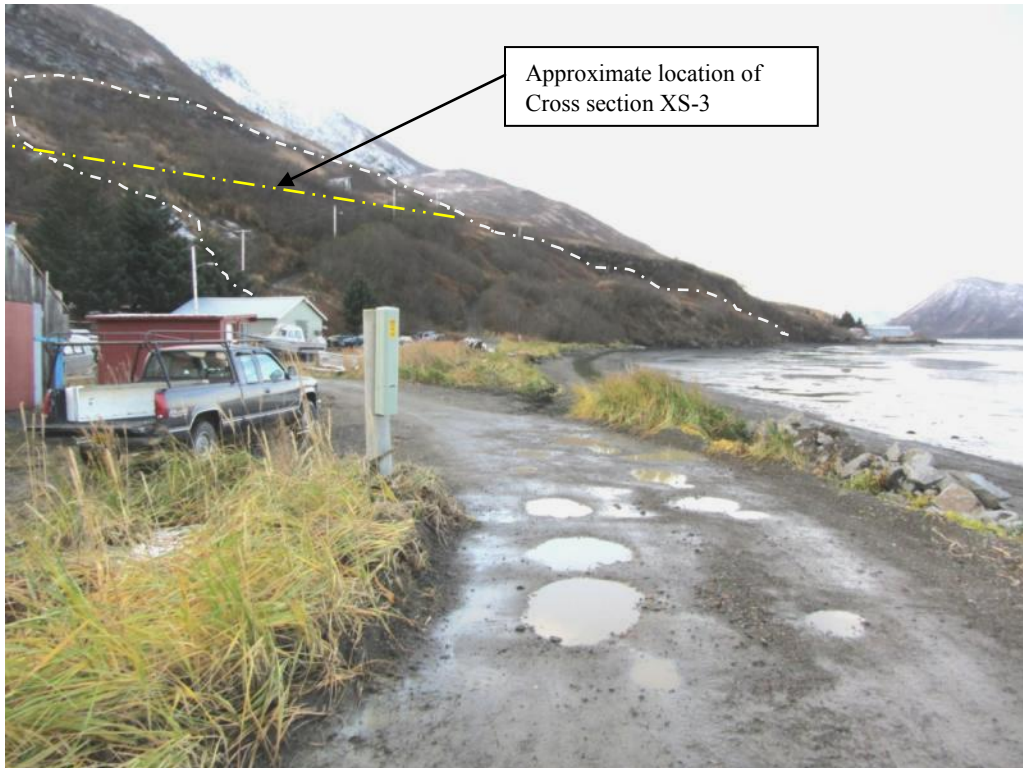
Photograph 2: Looking SE at road alignment (yellow line) and ancient landslide area (white line).

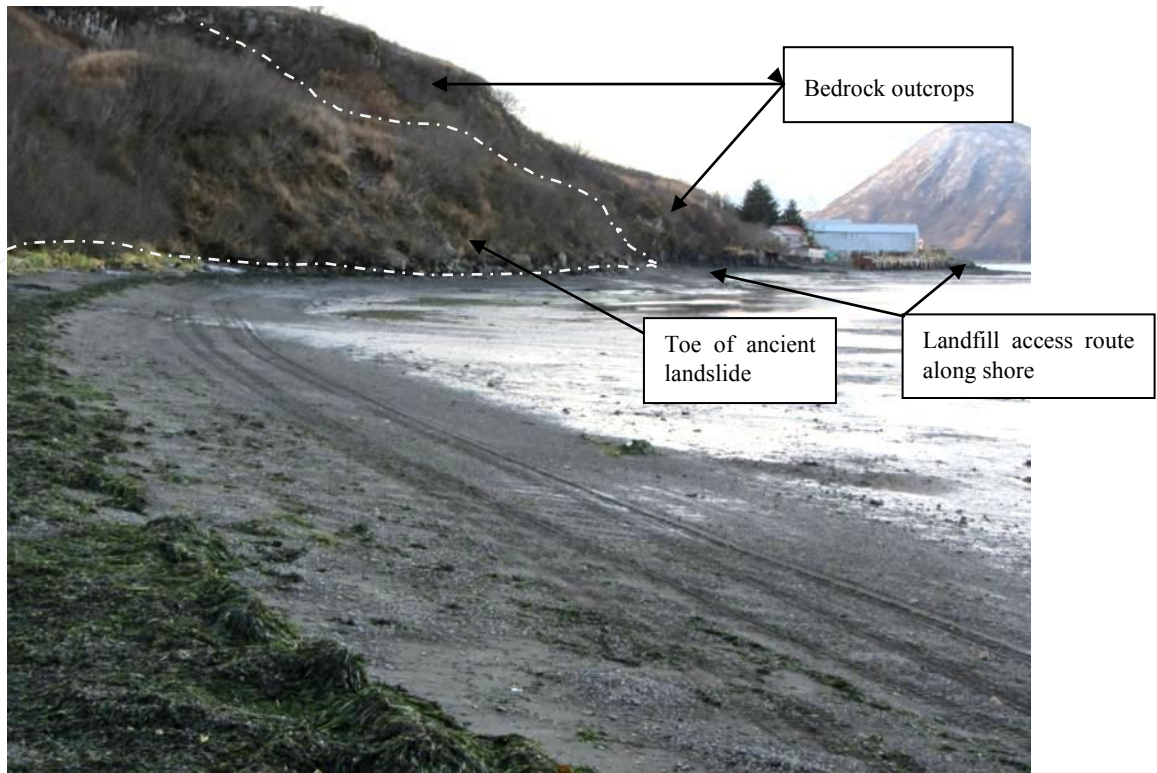
Photograph 3: Looking SW at landfill access road along shoreline and toe of ancient landslide. Bedrock exposed in cliffs above landslide.

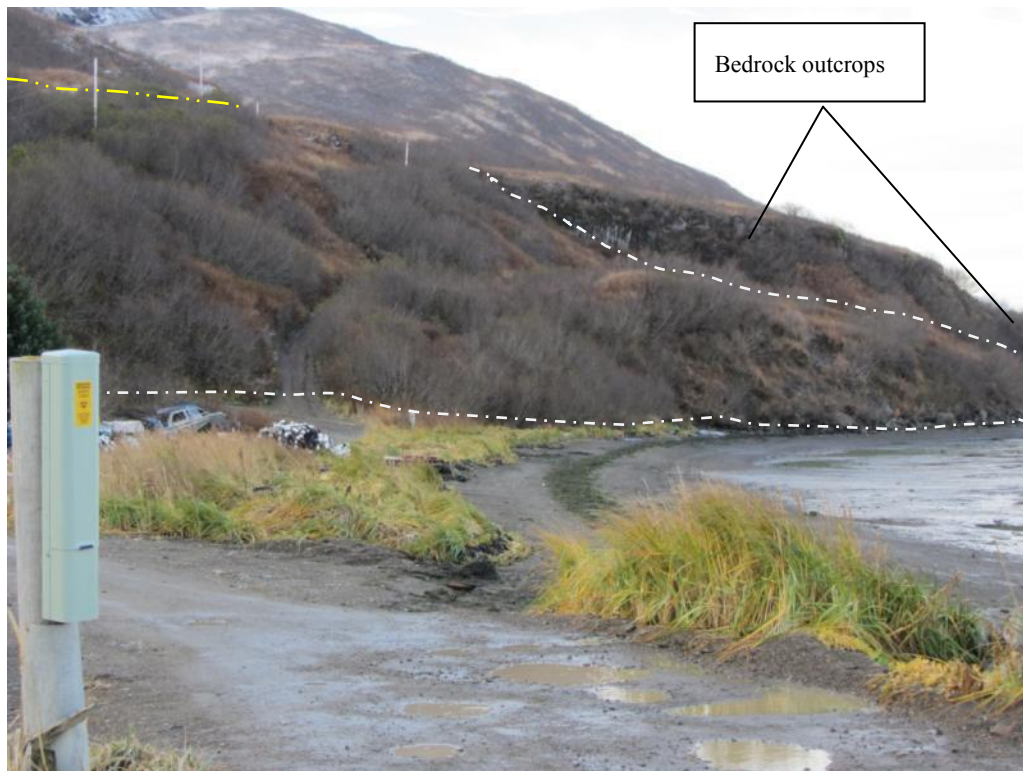
Photograph 4: Close up of toe of ancient landslide. Proposed road alignment shown by yellow line.

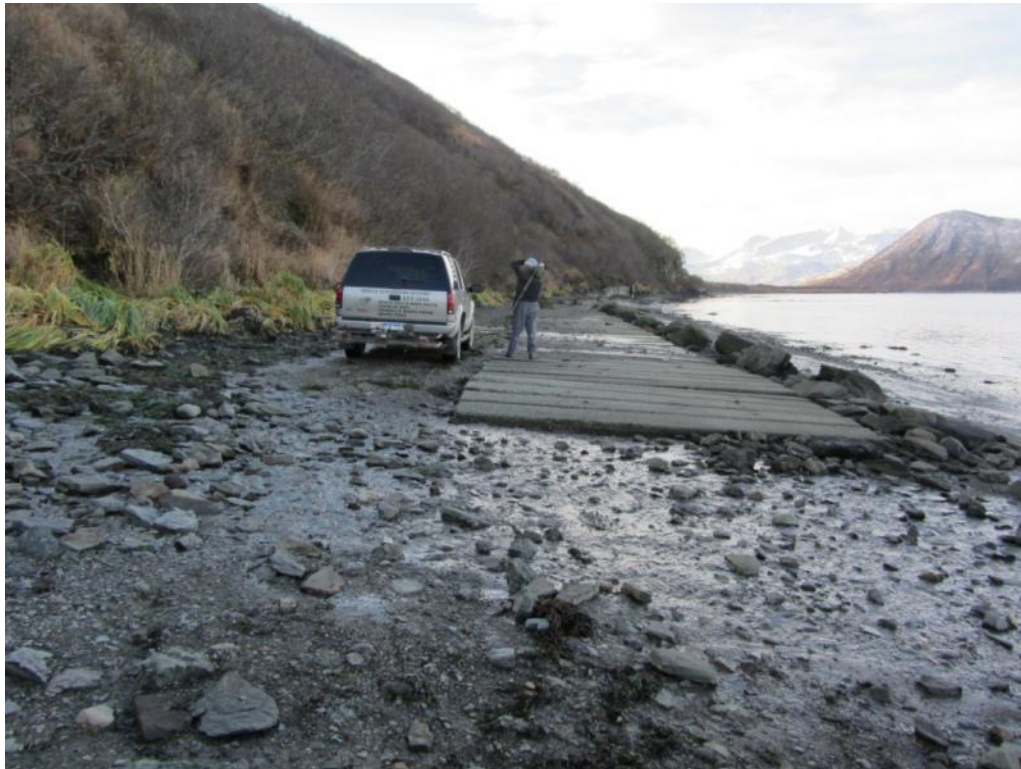
Photograph 6: Looking SSW along landfill access. Concrete road pads in foreground. Colluvium soil veneer overlaying bedrock is visible on hillside adjacent to shoreline.

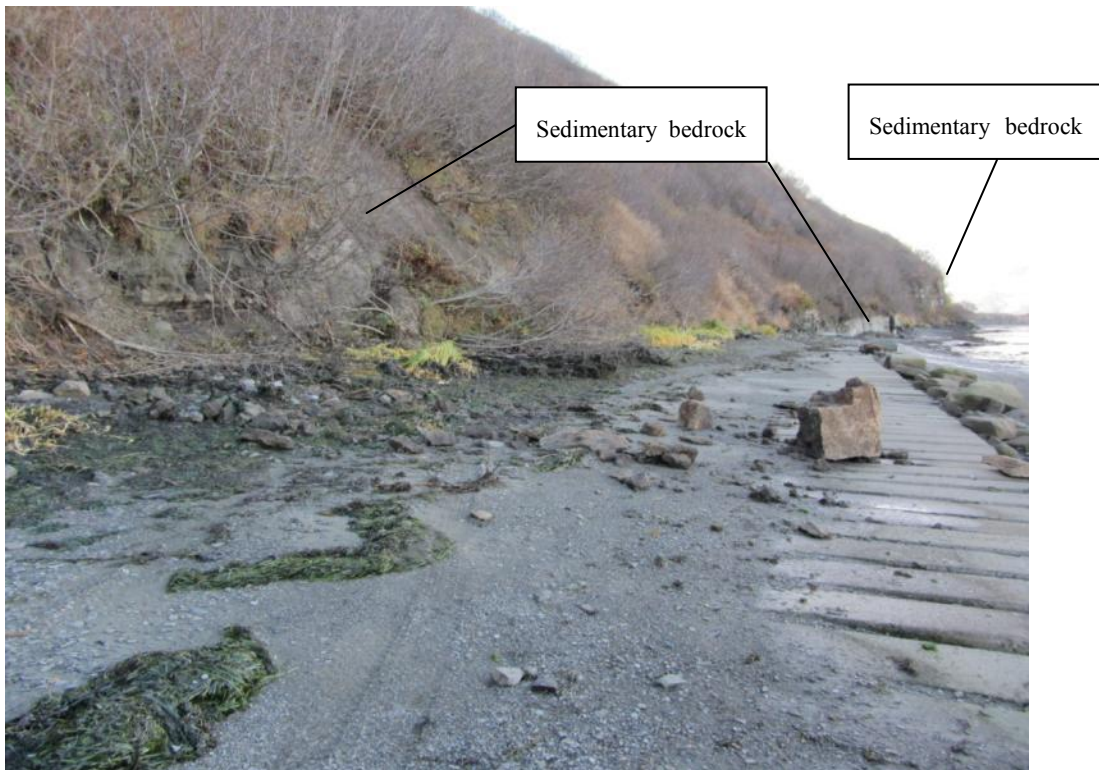
Photograph 7: Looking SSW along landfill access. Sedimentary bedrock exposed at toe of hillside. Bedrock exposed in cliffs in background.

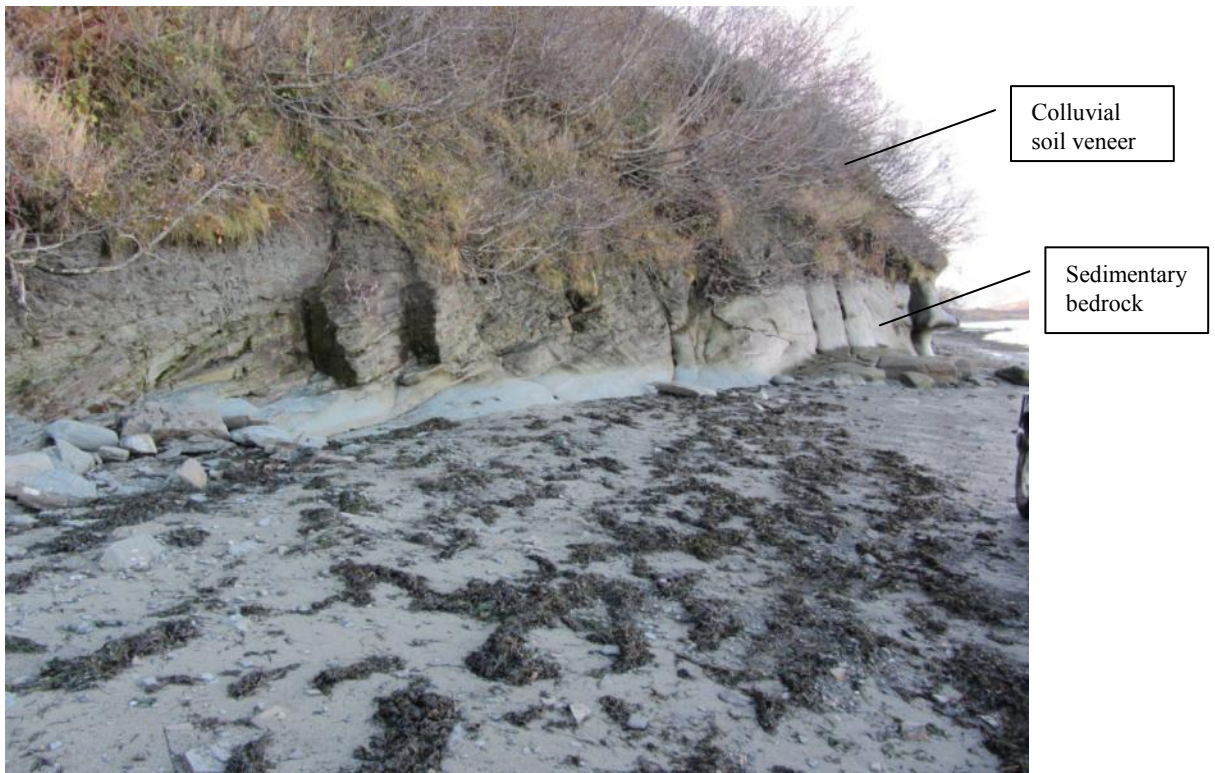
Photograph 8: Sedimentary rock outcrop with colluvial soil veneer along landfill access roadway (near station 664+00).

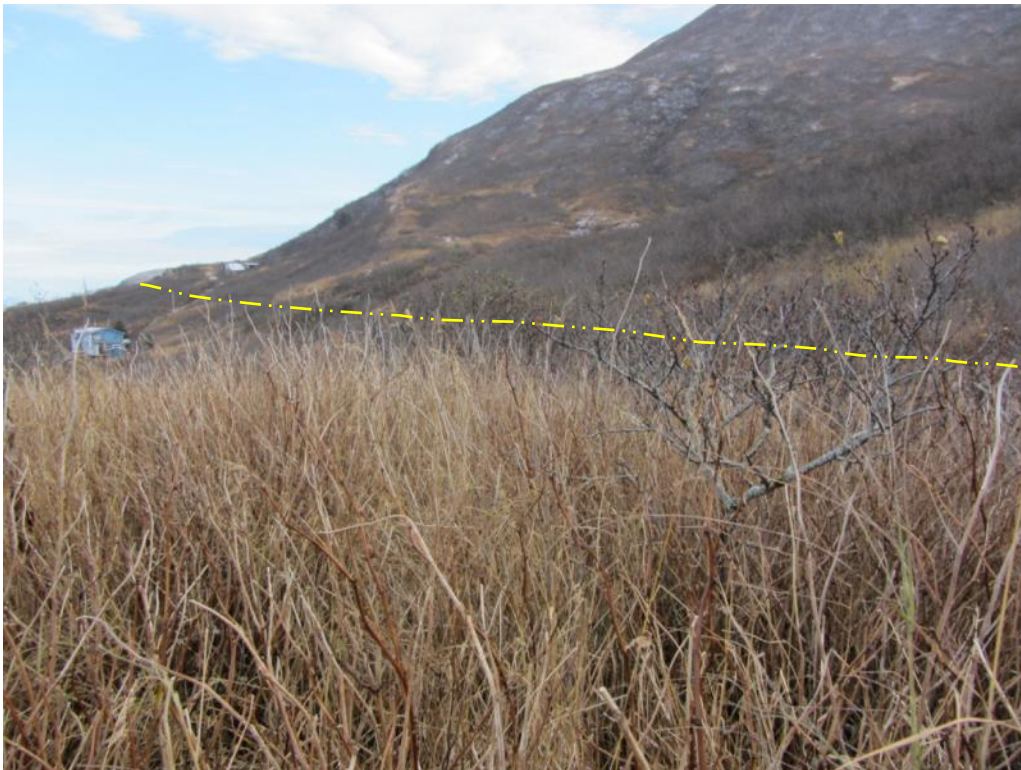
The alignment “side hills” across very steep terrain between stations 645+00 (photographs P-12 and P-14) and 675+00 (photograph P-11A). Cross sections XS-1 (+/-station 655+00) and XS-2 (+/- station 665+25) indicate steep side slope angles of 1H:1V (horizontal to vertical) along these alignment areas. The alignment also crosses some smaller incised drainages between these stations. The alignment crosses the relatively large Jerrys Point Creek drainage at station 681+30. Between approximate stations 690+00 and 700+50 the alignment crosses an ancient landslide (photographs P-2, P-3 and P-4). Cross section XS-3 (photograph 2) indicates an existing ground slope angle of approximately 1H:1V. From station 700+50 to 707+00 the alignment crosses a structural bench. Natural slope angles along this bench are relatively low angle. As stated previously, the geology along the alignment, with the exception of drainage crossings and the landslide locations, consists predominately of colluvial soils overlaying bedrock at varying depths. It was not possible to determine depth to bedrock by visual inspections. Test pits or drilling will be required to accurately determine the thickness of the colluvial soil cover at specific locations. With the exception of the ancient landslide area, there were no blatant indications of active landslide zones along the hillside alignment. However, the extensive vegetation and difficult access due to the very steep terrain made it very difficult to visually identify subtle indications of potentially unstable areas.

Photograph 11: Proposed road alignment looking NE from station 675+50.

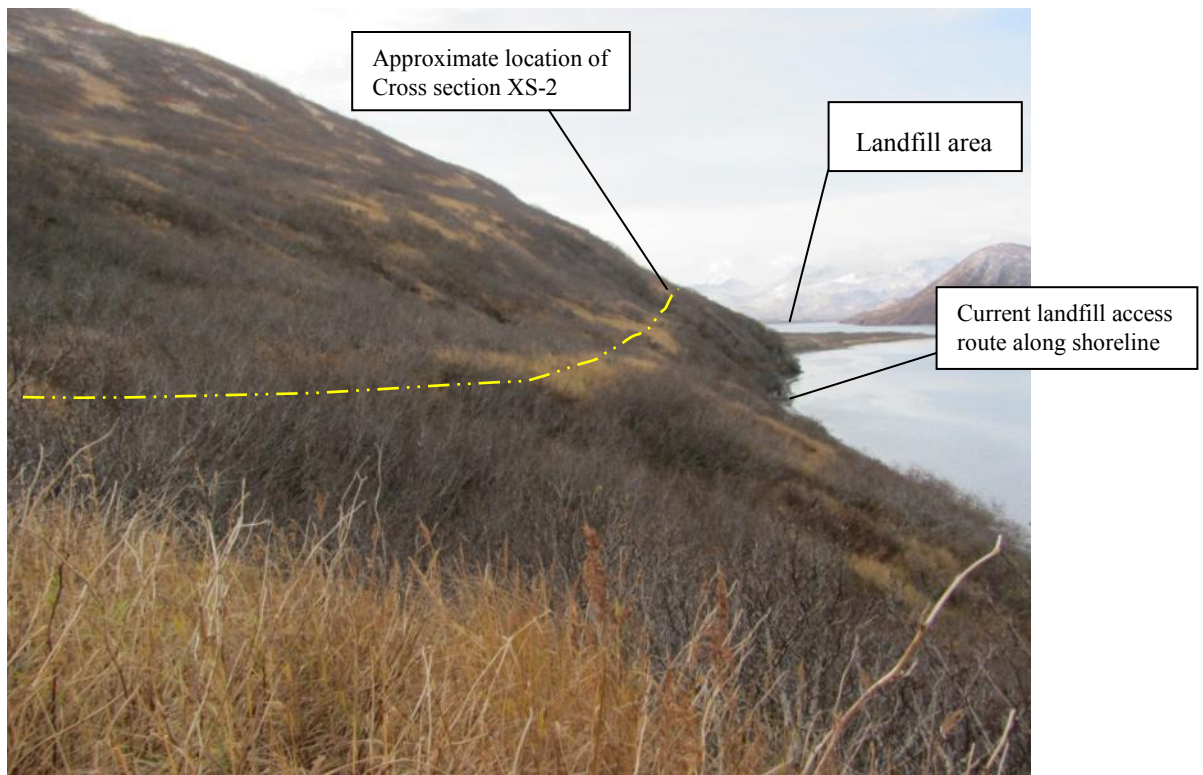
Photograph 11A: Proposed road alignment from station 675+50 looking SSW. Landfill area in background.

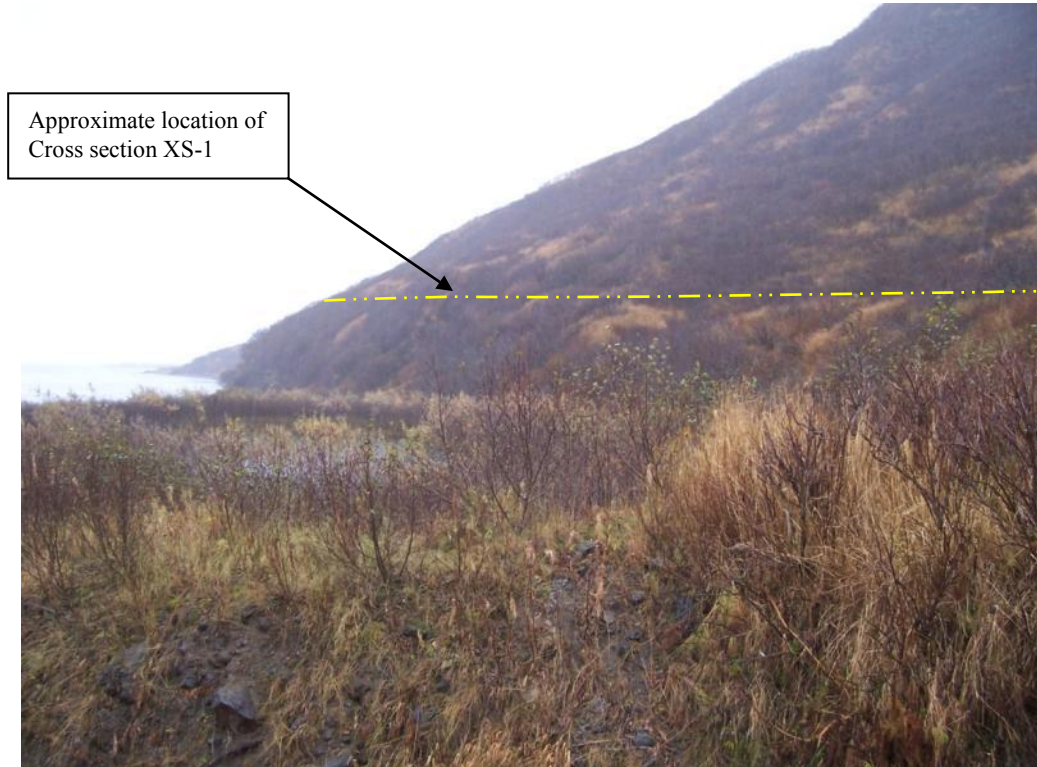
Photograph 12: Looking NE from berm between landfill and lagoon at alignment on hillside.

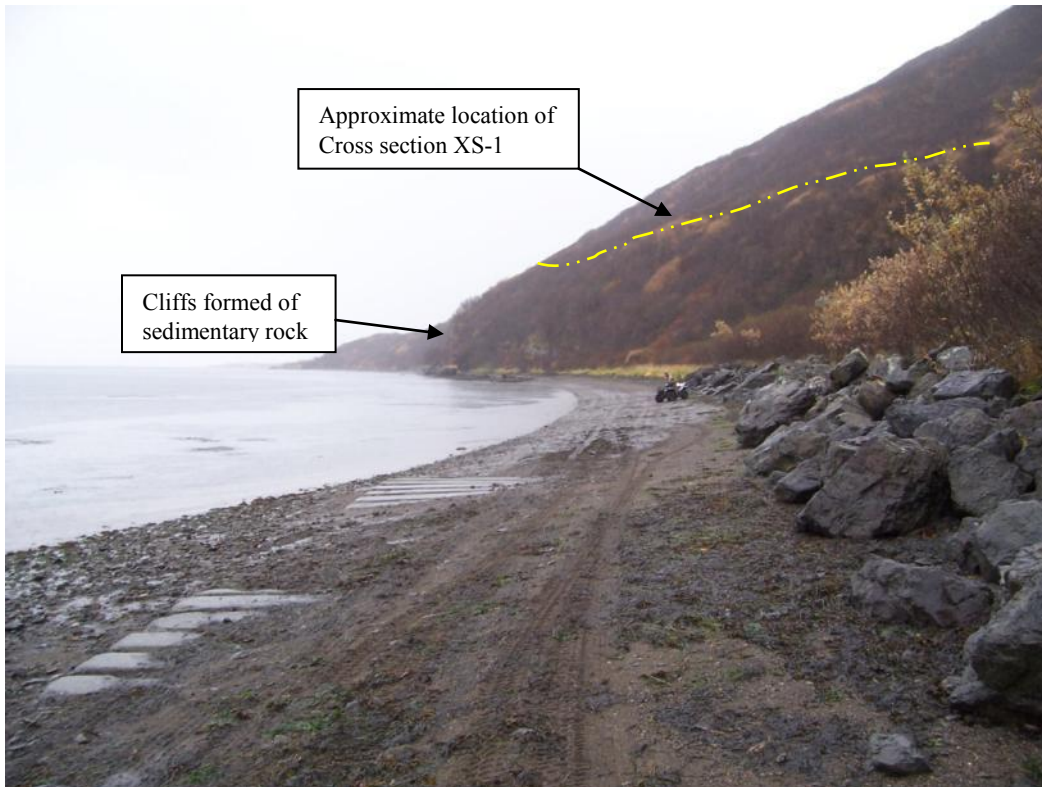
Photograph 14: From shoreline by landfill looking NE along landfill access and hillside route alignment (yellow line).

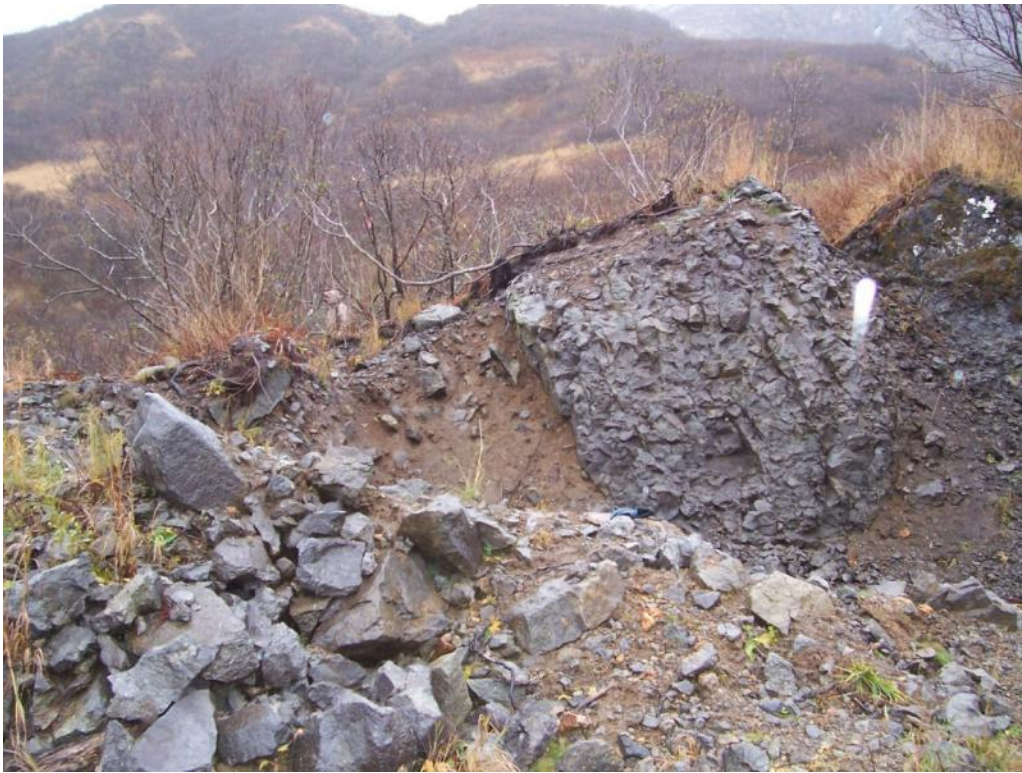
Photograph 17: Test pit excavation by landfill showing silty gravel colluvium and large blocks of volcanic rock.

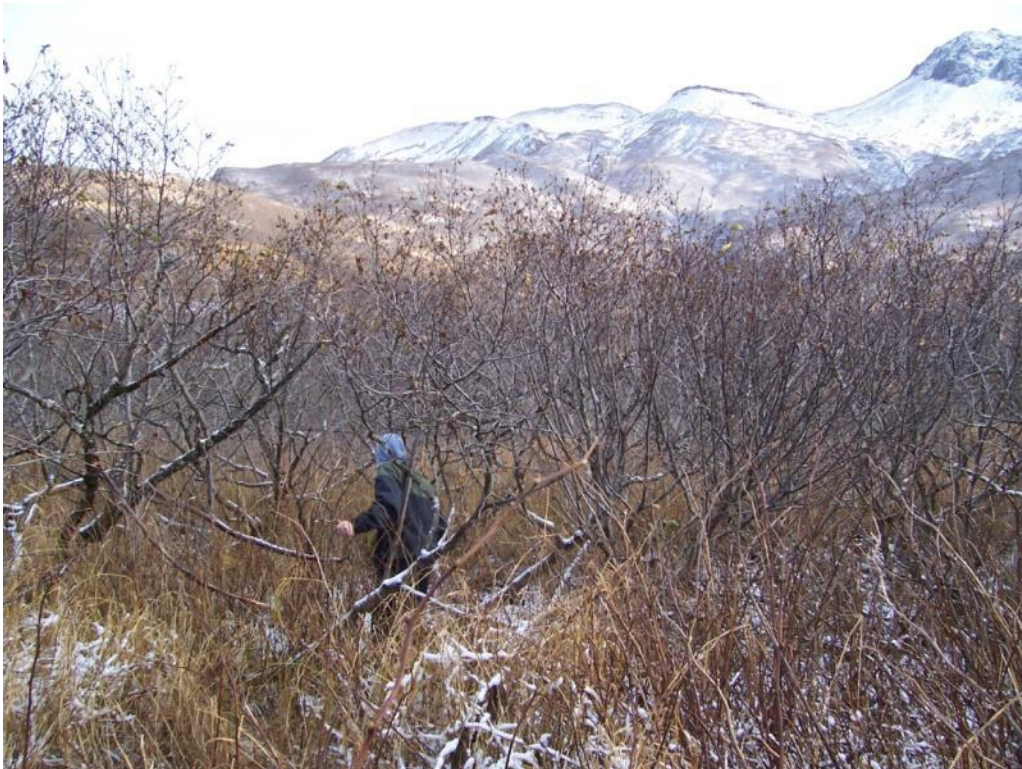
are included in Appendix B. Select typical cross sections taken along the hillside alignment are presented in Appendix C. Laboratory test results from the field samples are included in Appendix D. Access and visual assessment of the surficial geologic conditions along the hillside route was challenging due the extensive, dense vegetation and steep topography (See photograph P-18, Appendix B)

Photograph 18: Typical dense vegetation encountered along alignment (8- to 12-foot alders with salmon berry bush and mixed grasses).

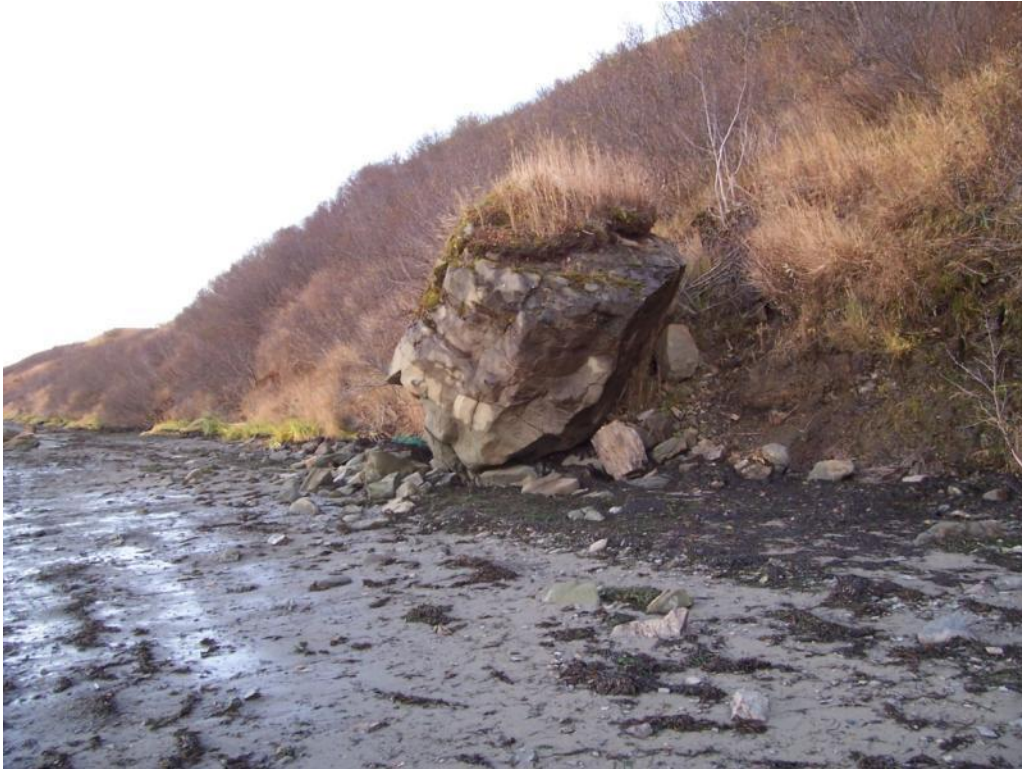
Photograph 19: Showing colluvial slope / marine sediment interface along landfill access route. Colluvium consists of angular cobble and boulder size sedimentary and volcanic rocks in sand, silt and clay matrix. Large boulder “rockfall is infrequent.

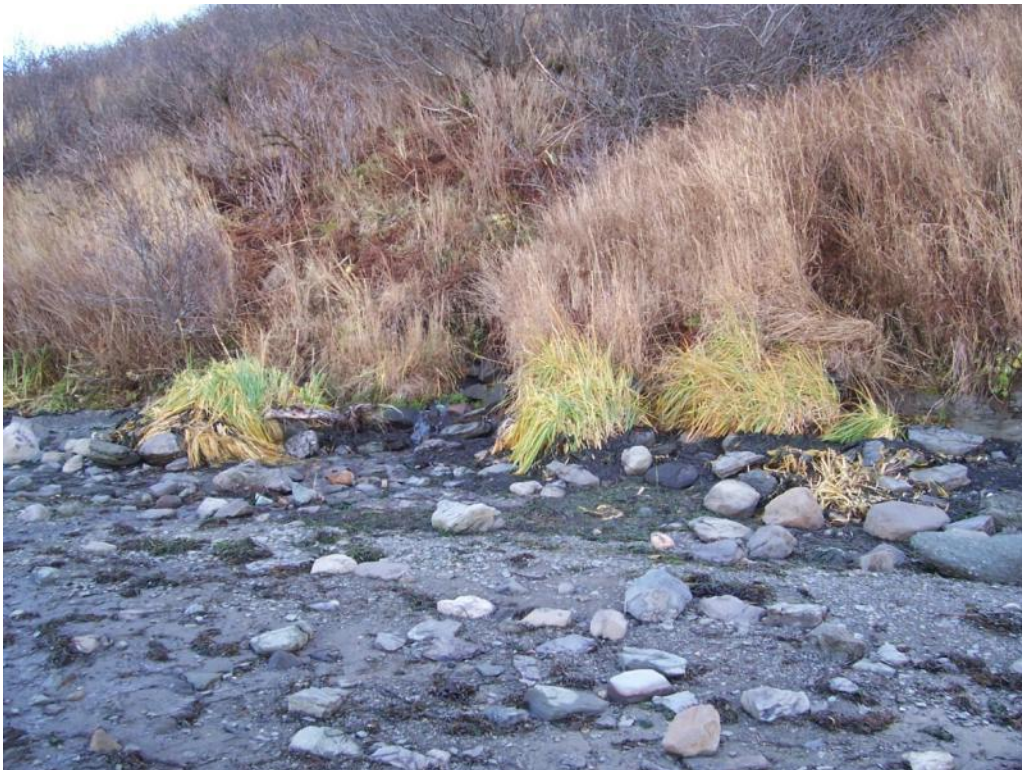
Photograph 20: Showing colluvial slope / marine sediment interface along landfill access route.

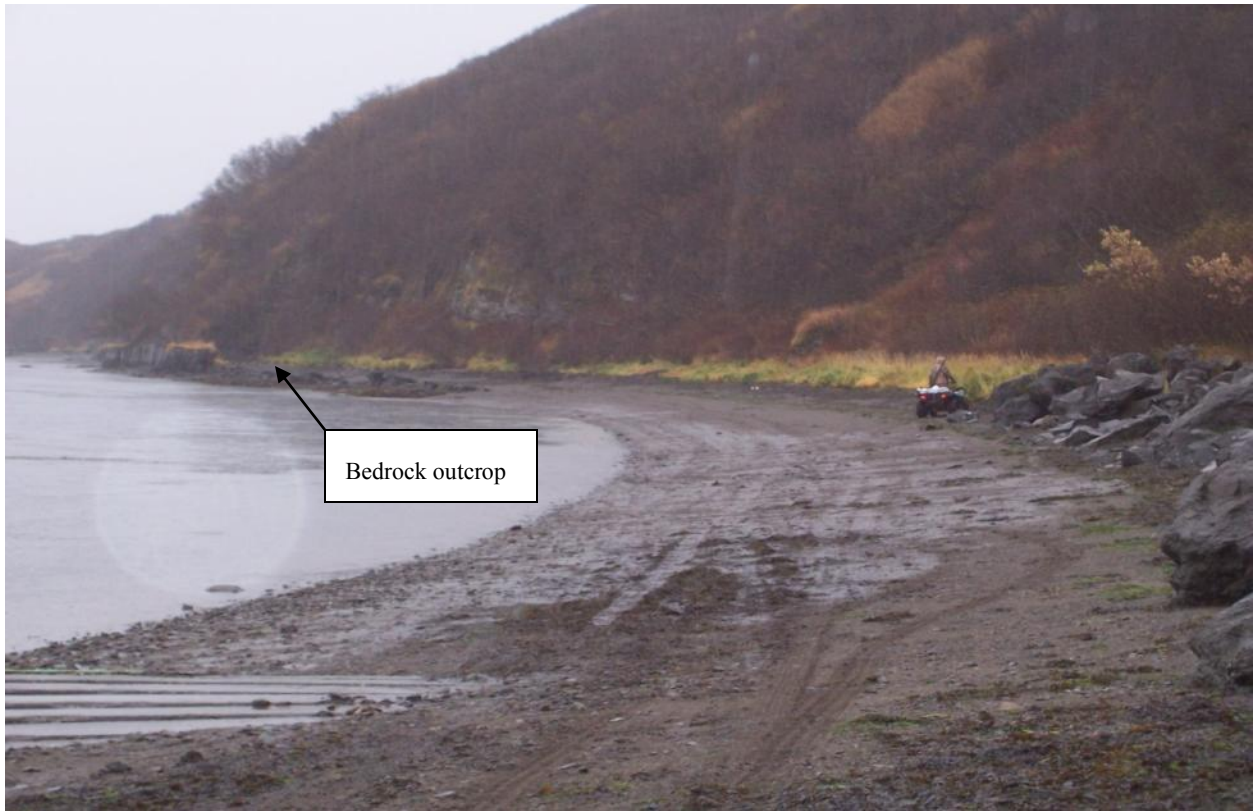
Photograph 21: Showing bedrock subgrade area just northeast of sewer lagoon and landfill. Landfill access road concrete pads in foreground.

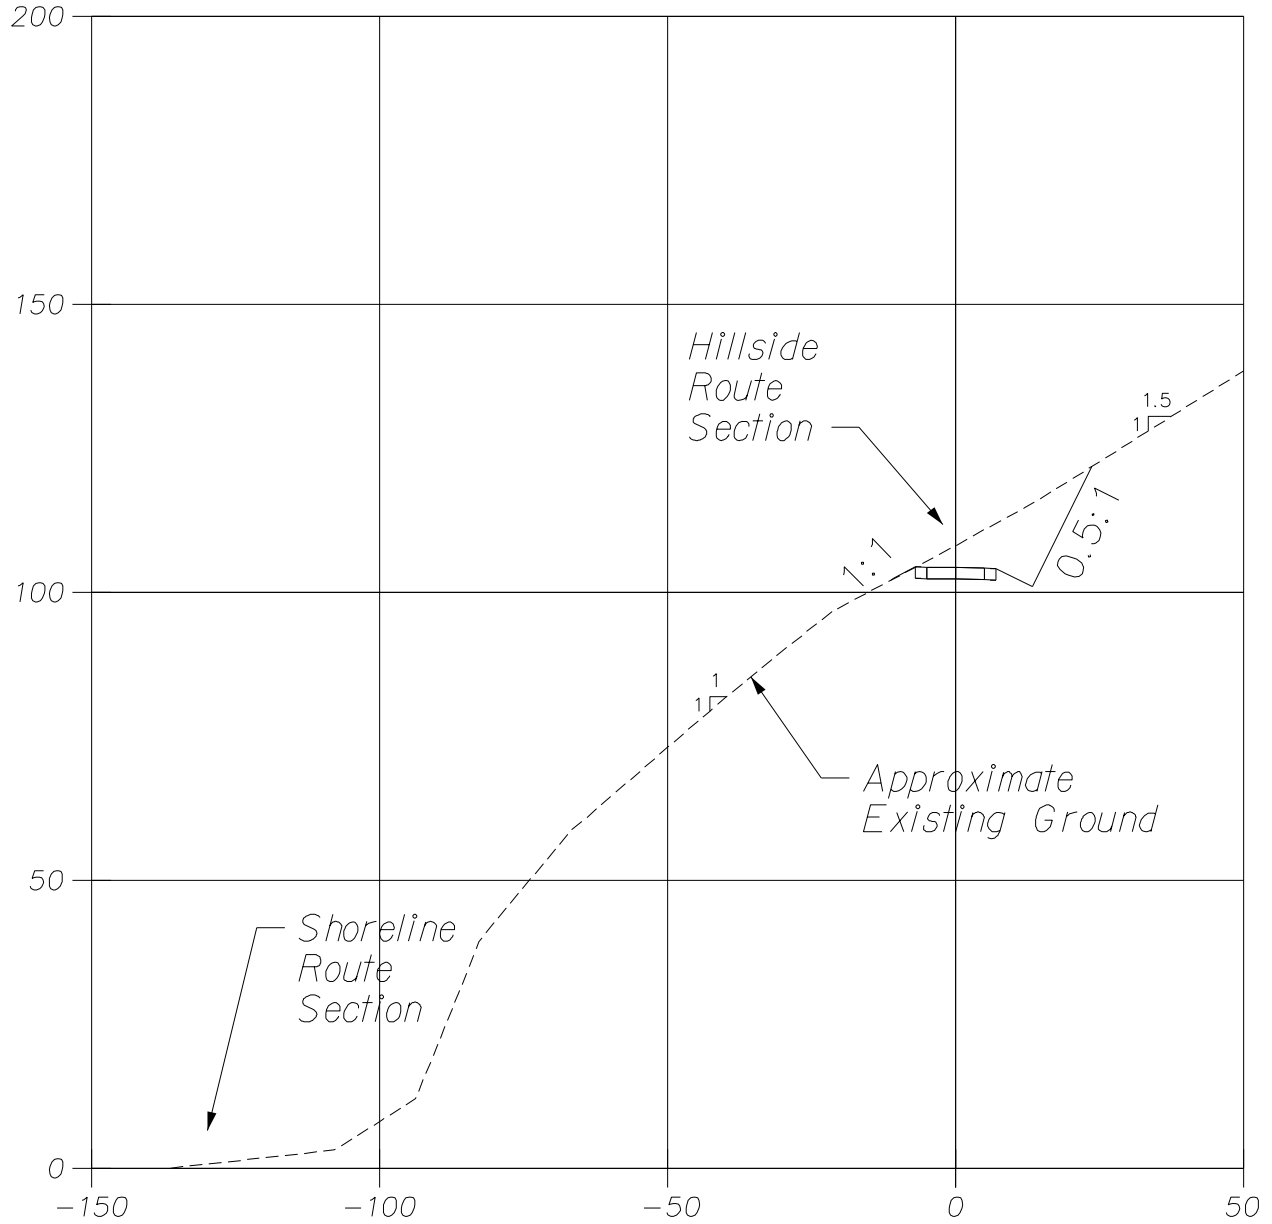
XS-1

Cut slope stability. The alignment side hills very steep terrain for the majority of the distance between the landfill and Village of Chignik Lagoon. The existing ground slope angles approach 1H:1V (horizontal to vertical) at the steepest areas. Typical cross sections shown in Figures XS-1, XS-2 and XS-3 indicate that, in order to catch the existing ground at reasonable distances from the roadbed, the backslope angles would have to be at 0.75H:1V or 0.5H:1V. These angles would still intersect the existing ground at heights equal to or greater than 25 feet above the roadbed.

Colluvial soils would not remain stable at 0.75H:1V cut slope angles and raveling would likely be excessive. There is also the potential that more significant global instability could occur further upslope as a result of the excavations. At a minimum, soil nailing or other stabilization methodologies likely would be required to maintain long-term stability for cut slopes at these angles within the colluvial soils.

Geotechnical investigations will be required to define subgrade conditions and to determine if the cut slope excavations would extend into competent bedrock or colluvial soils along these alignments and if the excavations would maintain adequate stability.
